Appendix F

APPENDIX F PHASE II SUMMARY and CONCLUSIONS

(Copied from Phase II ESA by Earthsystems Southwest, November 22, 2006)

TT 5632 Parklands, SWC Telegraph Rd & Wells Rd.
Ventura, California

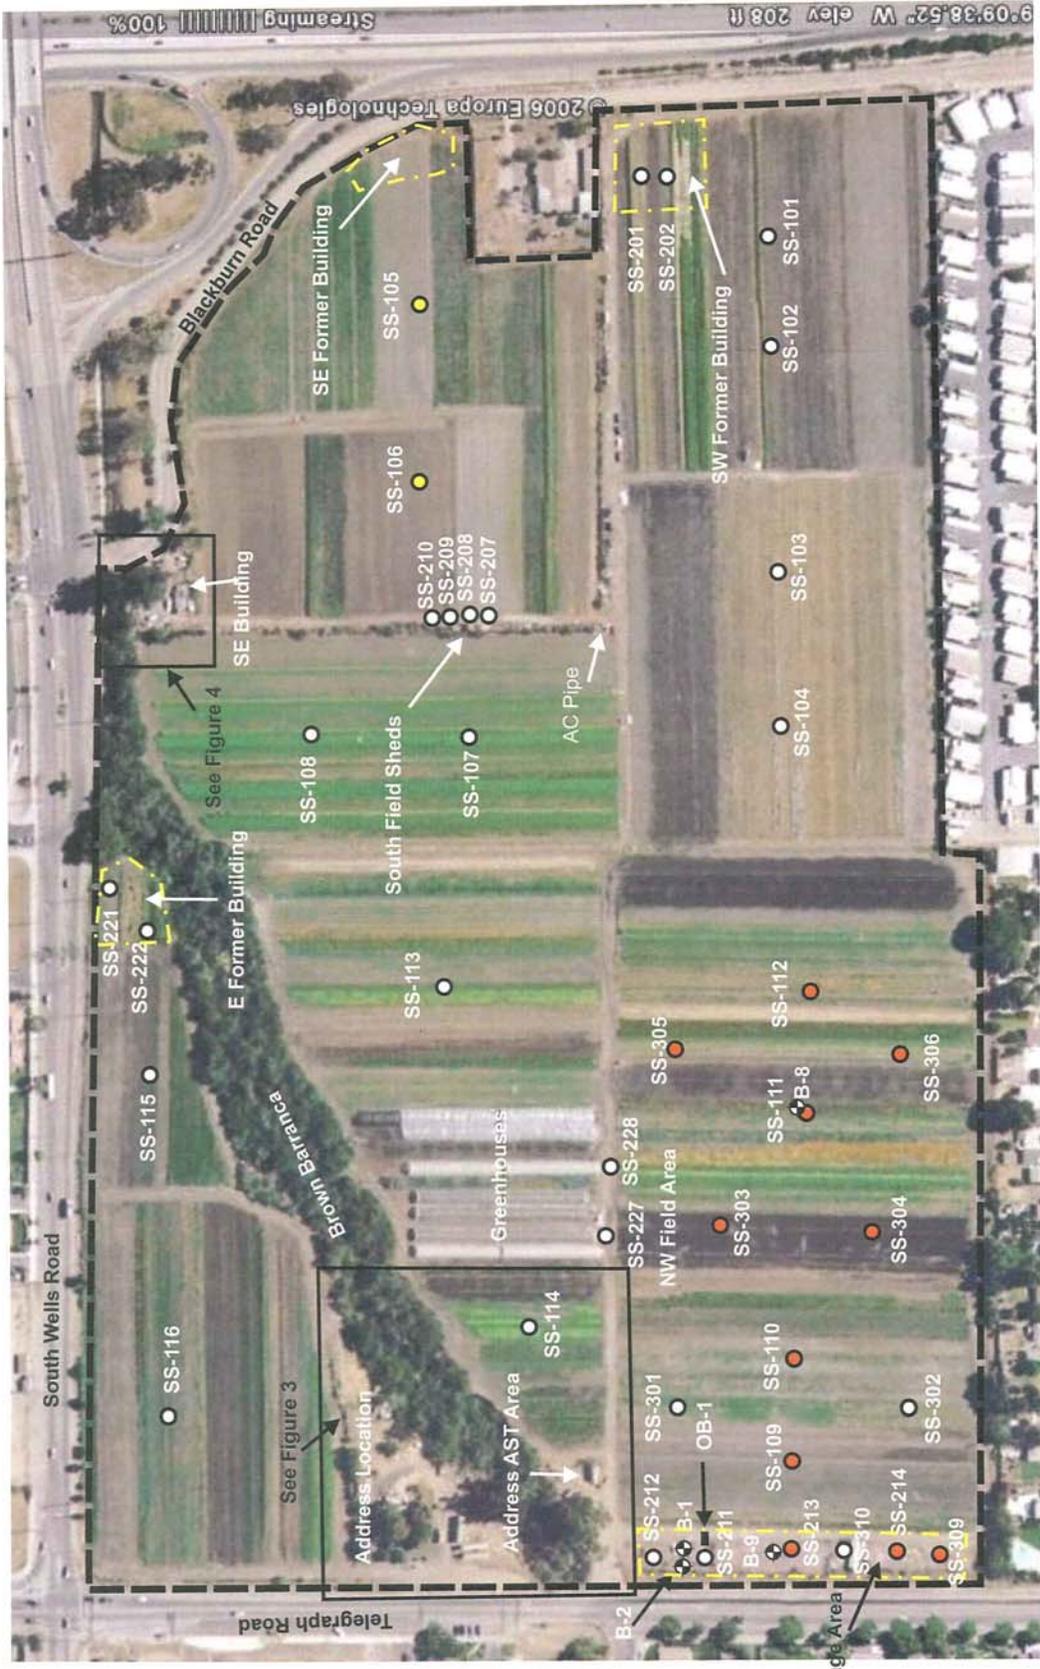
Figure 2
Sample and Boring Locations

Eight of ten surface samples collected in the field area at the northwestern part of the site [NW Field Area] contained concentrations of TDE (the combination of the values of DDT, DDD, and DDE) that slightly exceeded the TTLC value of 1.0 mg/kg (maximum value of 2.34 mg/kg in SS-111). A boring to 5 feet below ground surface [bgs] was completed at the location of SS-111 and samples were collected at 1 foot, 3 feet, and 5 feet bgs. DDE and DDT residues were detected at 1 foot bgs at 0.018 and 0.003 mg/kg, respectively. Other OCPs were not detected above laboratory reporting limits at 1 foot. OCPs were not detected above laboratory reporting limits for samples collected at 3 and 5 feet bgs. The uniform concentration of these residues in the NW Field Area is consistent with farming application.

Three of four surface samples collected in the western half of the NW Storage area contained detected concentrations of TDE (the combination of the values of DDT, DDD, and DDE) that slightly exceeded the TTLC value of 1.0 mg/kg (maximum concentration of 1.69 mg/kg TDE in SS-213). The concentration did not exceed the respective PRG-r and PRG-i values. A boring to 5 feet bgs was completed at the location of SS-213 and samples were collected at 1 foot, 3 feet, and 5 feet bgs. OCPs were not detected above laboratory reporting limits in the subsurface samples.

but the combined risk from all three would exceed the PRG-r goal in some of the samples. The combined risk from all three would be well below the PRG-i. **Consequently, it appears that the upper % foot of soil in the NW Field area is marginally above preferred values for use in a residential setting, and would be classified as a hazardous waste if the material were to be disposed of off-site. Therefore, we recommend that the uppermost soil be sequestered on-site to avoid exposure to these soils by future residents, such as placing the soil as fill in the Barranca area or under the proposed commercial portion of the site. The quantity of soil in question is approximately 11,200 cubic yards. It is recommended that the on-site mitigation options be coordinated with the Ventura County Environmental Health Division [VCEHD].**

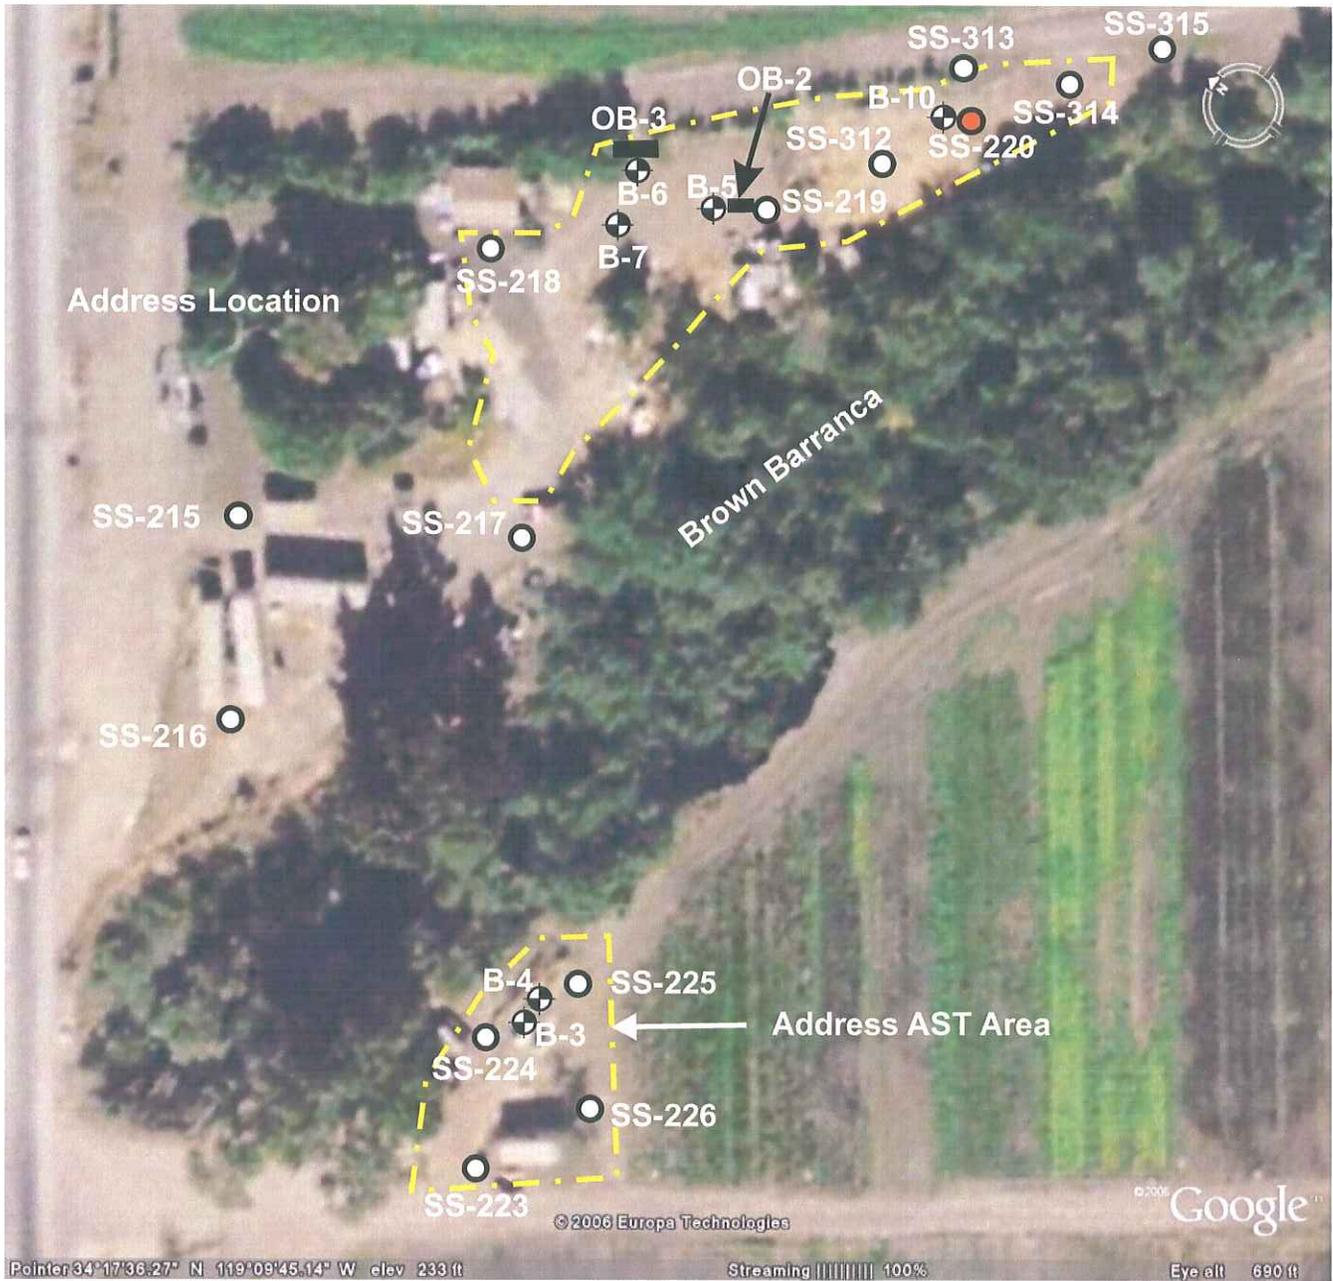
Figure 3
Address Location and Vicinity

One of six surface samples collected the southern part of the Address Location contained detected concentrations of TDE (the combination of the values of DDT, DDD, and DDE) that slightly exceeded the TTLC value of 1.0 mg/kg (maximum concentration of 1.1 mg/kg TDE in SS-220). The concentrations did not exceed the respective PRG-r and PRG-i values. Sample SS-220 also contained residues of Toxaphene at 1.1 mg/kg and Dieldrin at 0.050 mg/kg, which exceeded the PRG-r values of 0.44 mg/kg and 0.03 mg/kg (respectively) but do not exceed the PRG-i values of 1.6 and 0.11 mg/kg (respectively). This sample did not exceed the TTLC values for either Toxaphene or Dieldrin. A boring to 5 feet bgs was completed at the location of SS-220 and samples were collected at 1 foot, 3 feet, and 5 feet bgs. Toxaphene was detected at 1 and 3 feet bgs at concentrations of 0.047 and 0.021 mg/kg, respectively. Other OCPs were not detected above laboratory reporting limits in the subsurface samples at 1 and 3 feet bgs. OCPs were not detected above laboratory reporting limits in the sample collected at 5 feet bgs. The presence of OCP residues in the existing and former building and storage areas is likely the result of spillage from mixing and storage.

- In the storage area directly south of the Address Location, Sample SS-220 contained TDE residues that were slightly over the TTLC limit of 1.0 mg/kg, as well as residues of Dieldrin and Toxaphene that were over the PRG-r's. A boring completed at SS-220 found that pesticide concentrations decreased rapidly to less than the PRG-r's by a depth of 1 foot bgs. The volume of affected soil in this location is very small (about 2 cubic yards). **We recommend soils within a 10-foot radius of SS-220 to a depth of 0.5 feet be handled in the same manner as the surface soil in the northwestern portion of the site, with the concurrence of the VCEHD.**

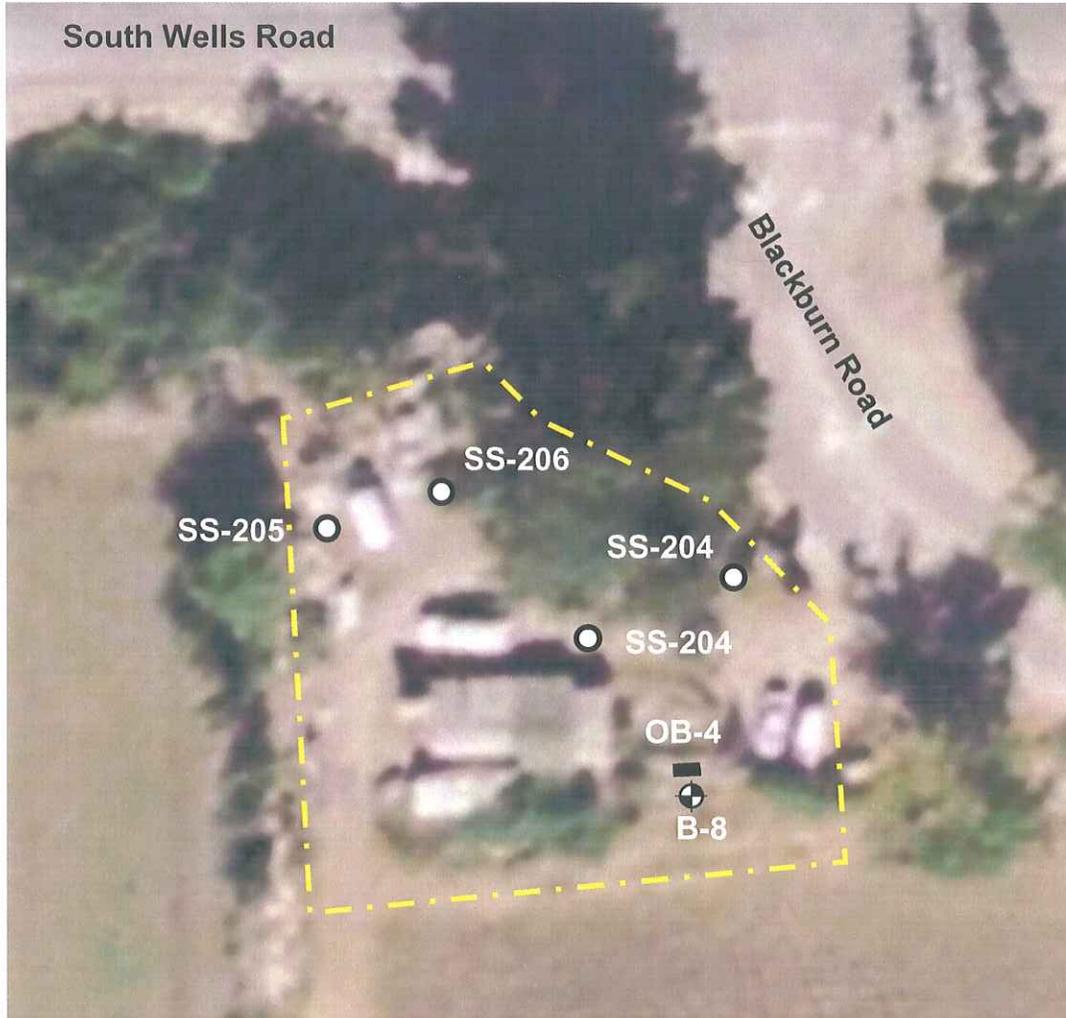
Figure 4
East Building Location

Geophysical surveys involving TCM and GPR were conducted at seven separate localities on-site, and four objects were detected (OB-1 through OB-4). OB-1, located near the gate of the enclosed area in the NW Storage area, had a geophysical signature that suggested a flat conductive (likely metallic) object about 3 feet by 2 feet in size. OB-2 and OB-3 were located in the south storage area of the Address Location, where the ESA indicated a UST was suspected to have historically existed. OB-2 was about 5 feet by 3 feet in size and OB-3 was about 10 feet by 3 feet in size. Both anomalies had a geophysical signature suggestive of a buried drum or UST. OB-4, located at the SE building location, was about 2 feet by 4 feet in size and is about 1 foot below the

surface. The geophysical survey did not detect conductivity anomalies in the other existing and former building and storage locations on-site.
