Building the Olivas Adobe

Adobe Repair Work

Seismic Strengthening of the Adobes

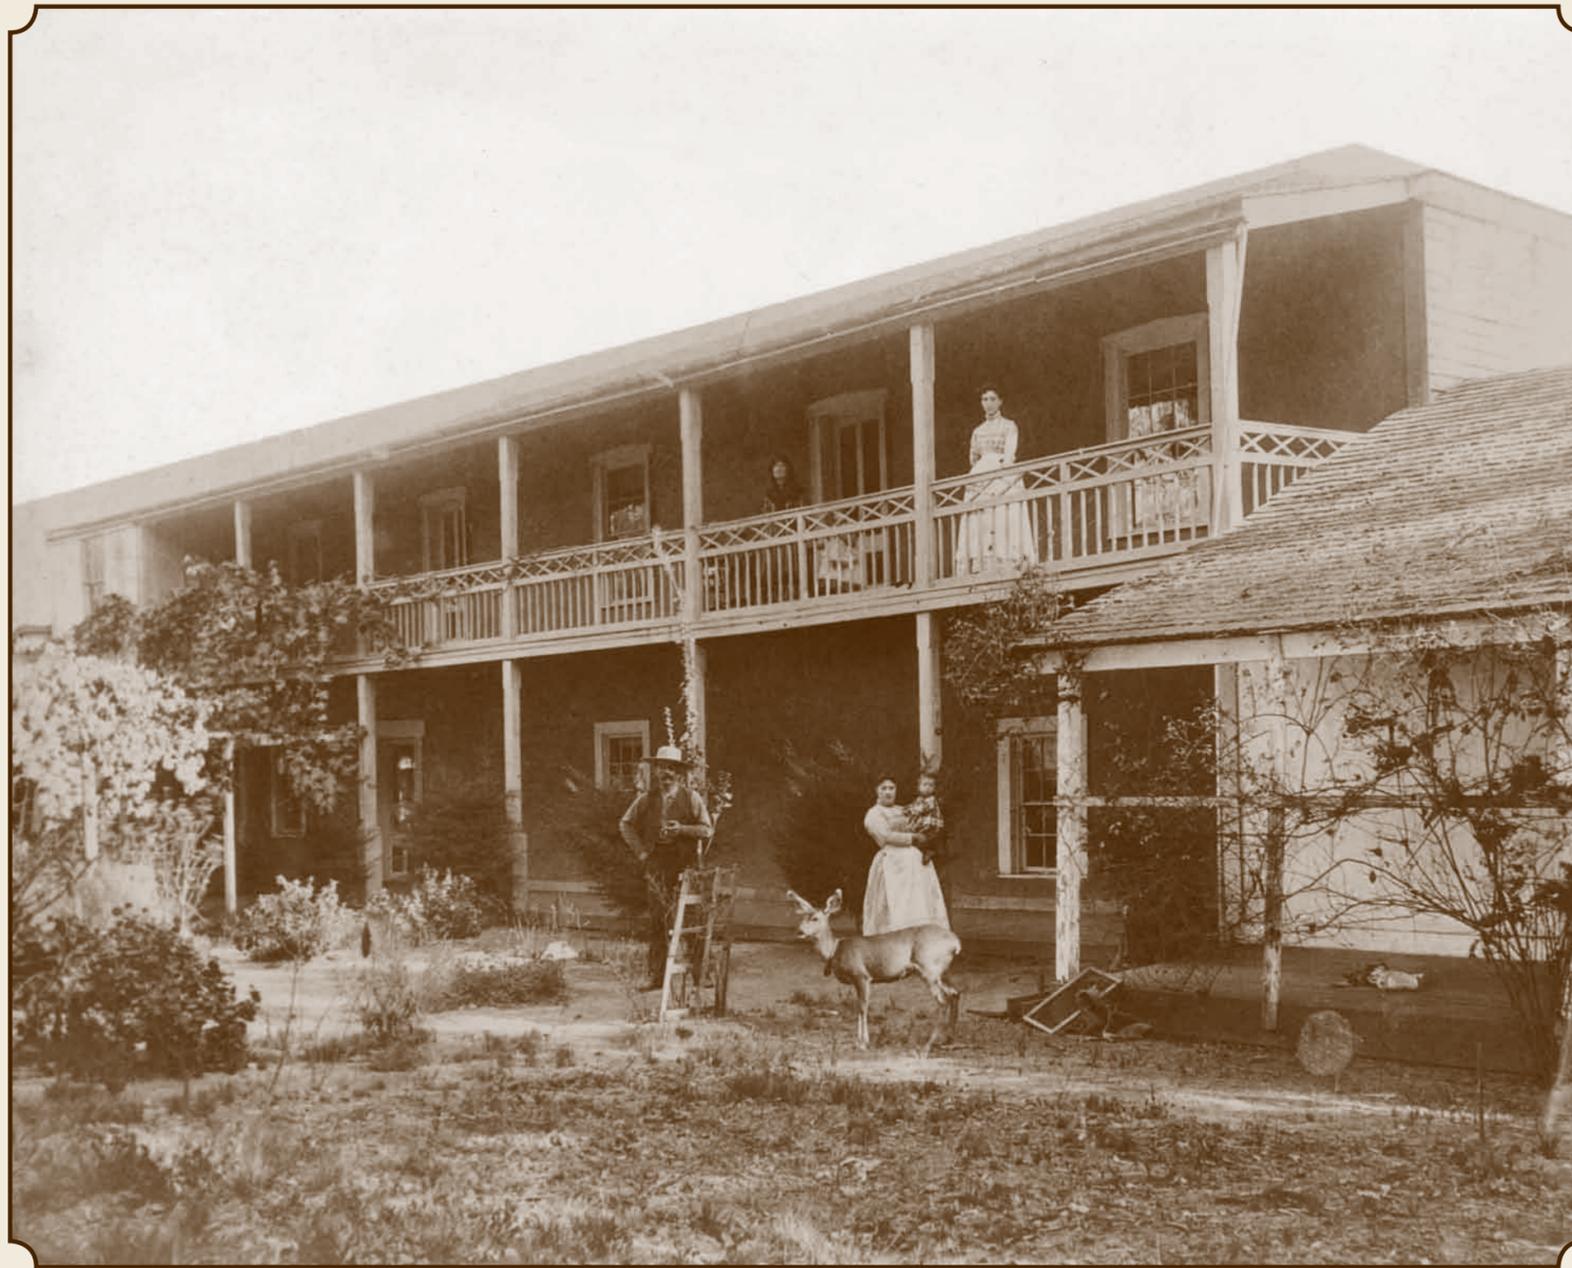
The Olivas Adobe, circa 1890.

*Balcony: Doña Teodora Olivas with her daughter Francesca Olivas Suytar;
ground floor: son Raimundo Olivas Jr., daughter Rebecca Olivas De La Riva holding child, and pet deer.*

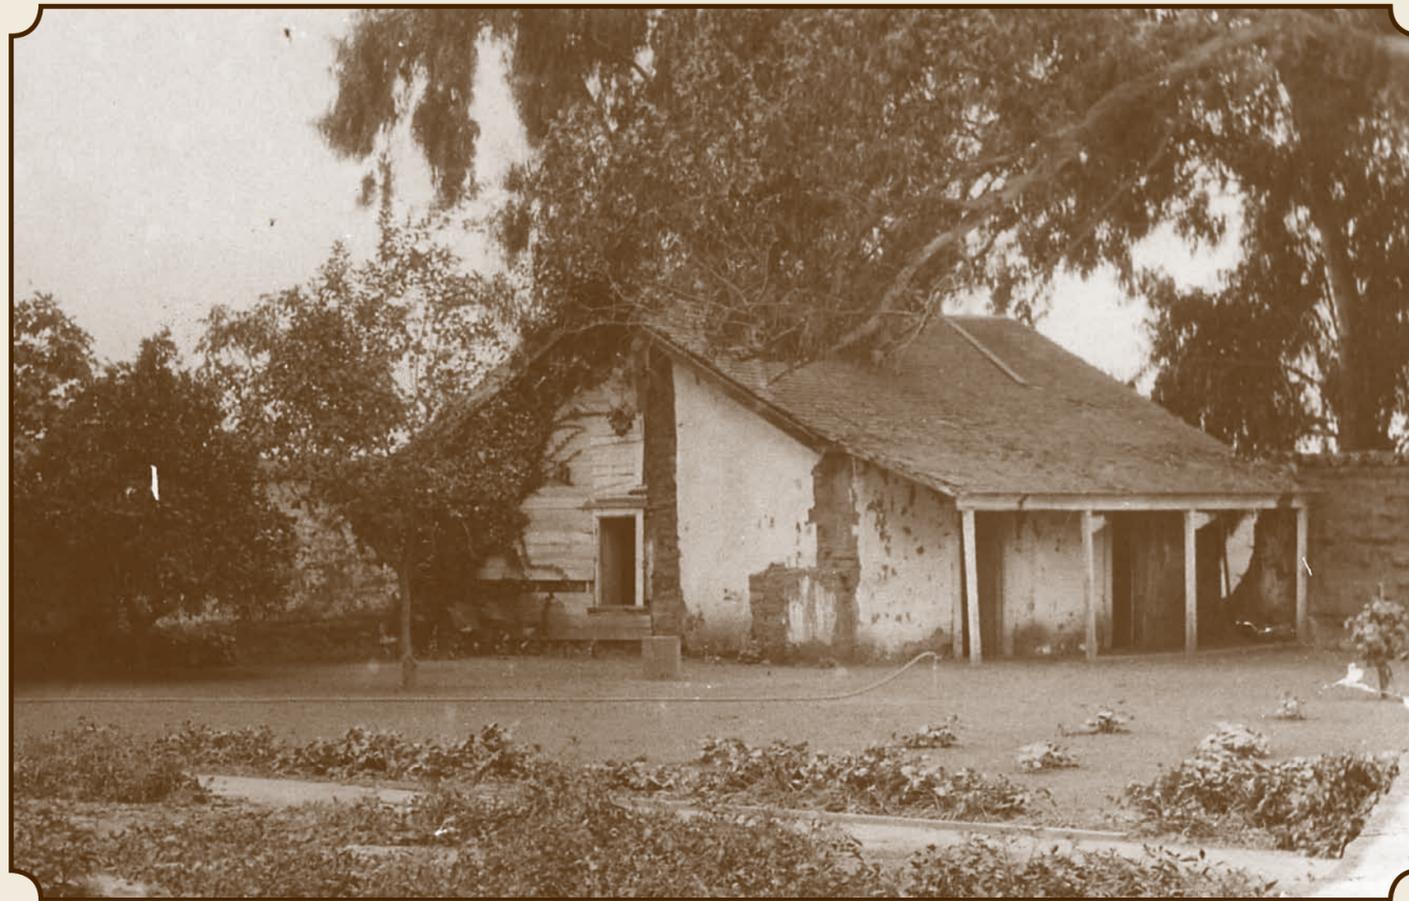
Small Adobe, circa early 1920s.

This small adobe, as it now stands, and the courtyard walls were built sometime after 1855, at the height of the rancho operation. An archaeological excavation conducted through the floor of the

small adobe found the remains of an older adobe structure possibly built in the 1840s, as well as artifacts related to rancho life. Although there were likely other small adobe buildings on the site when

the Olivas family lived here, this is the only small adobe structure remaining. The courtyard served as the center of family life and ranch business. Lavish fiestas were held here, lasting as long as a week.

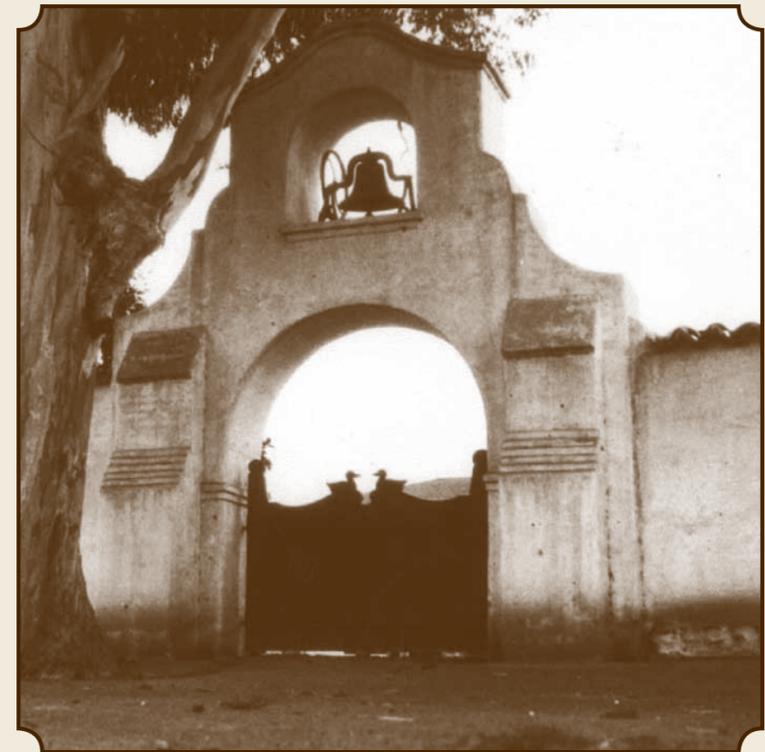
Bell gate created during the Fleischmann period with duck carvings.

In addition to serving as the Olivas family home, the adobe has been a dairy and a hunting club. Max Fleischmann purchased and restored the house in 1927, building this distinctive bell arch over the main gate to the courtyard. Mr. Fleischmann maintained the property as his private hunting lodge. The adobe was given to the City, after the death of Max Fleischmann in 1951, by the Fleishmann Foundation in 1963 and made into an historic park in 1974, highlighting the many contributions of early Latino pioneers.

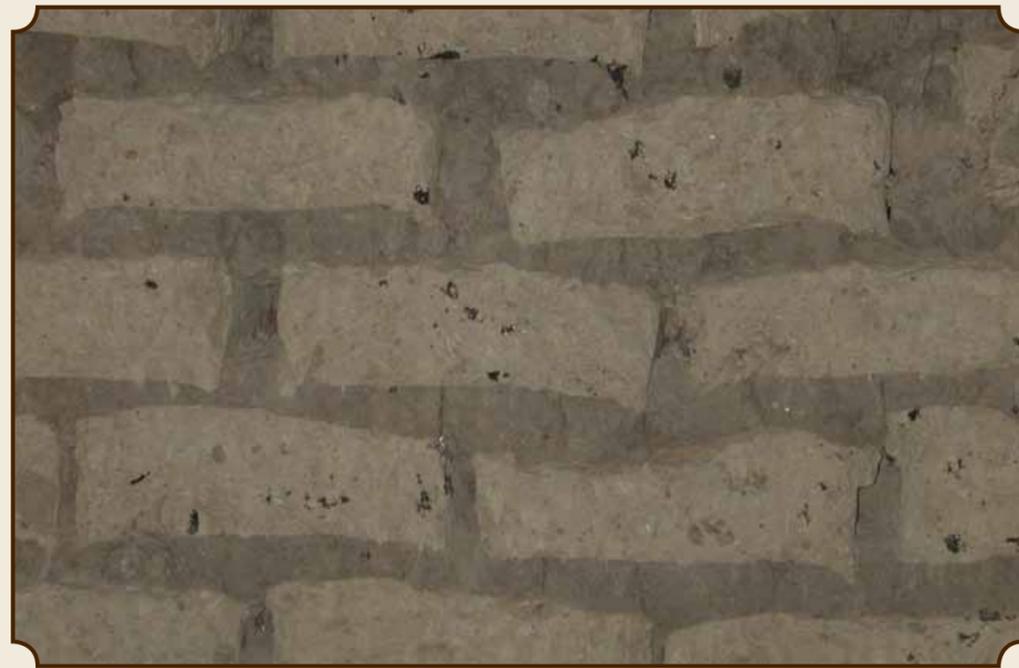
19th Century Adobe Bricks

Exposed bricks in this wall (behind the framed glass) are the original adobe bricks used in constructing the wall sometime after 1855. Adobe bricks are basically mud bricks, traditionally made from a mixture of mostly soil and water, with a small

amount of added sand and chopped straw (or recycled straw in the form of horse dung). The thick compound was then packed tightly into a wooden frame. When the frame was removed, the brick was left to dry in the sun for many days, turned occasionally.

A typical adobe brick from the original construction measures approximately 22" by 11" by 4½" and weighs about 25 pounds. The nine rooms of the main house are composed of about 2,000 or more bricks per room.

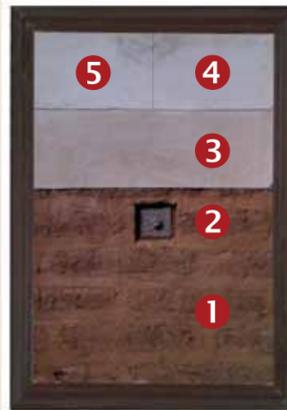
Layers: Behind this glass you can see the various layers of repair work on this wall. Portions of the wall had deteriorated and needed to be replaced.

❶ The replacement adobe bricks are made of soil mixed with water, and small amount of sand and organic material (chopped straw). Adobe mud mortar consisting of sand, soil and water was used to fill the void between the new adobe bricks and the existing adobe wall.

❷ The outer layer of replacement adobe bricks on this wall was attached

to the existing 19th century adobe wall with stainless steel rods in a rectangular grid pattern (see metal cap).

Two coats of lime plaster—crushed limestone heated in a kiln, plus sand and water—were applied:

❸ one rough coat and

❹ a second smoother finish layer with finer grain sand.

❺ Finally, the lime plaster was covered with two coats of thin whitewash—a finish made of finely ground lime and water, with a small amount of a glue-like binder added.

The outer courtyard wall surfaces were repaired with mud mortar applied to the 19th century adobe brick surfaces, and then covered with two layers of lime plaster and whitewash.

The repair process for the two-story house was slightly different, using the traditional construction methods originally used for the house: The adobe brick surfaces were repaired with mud mortar and then covered with two layers of mud plaster (a rough layer and a smooth finish layer). This was followed by four coats of a thin whitewash finish.

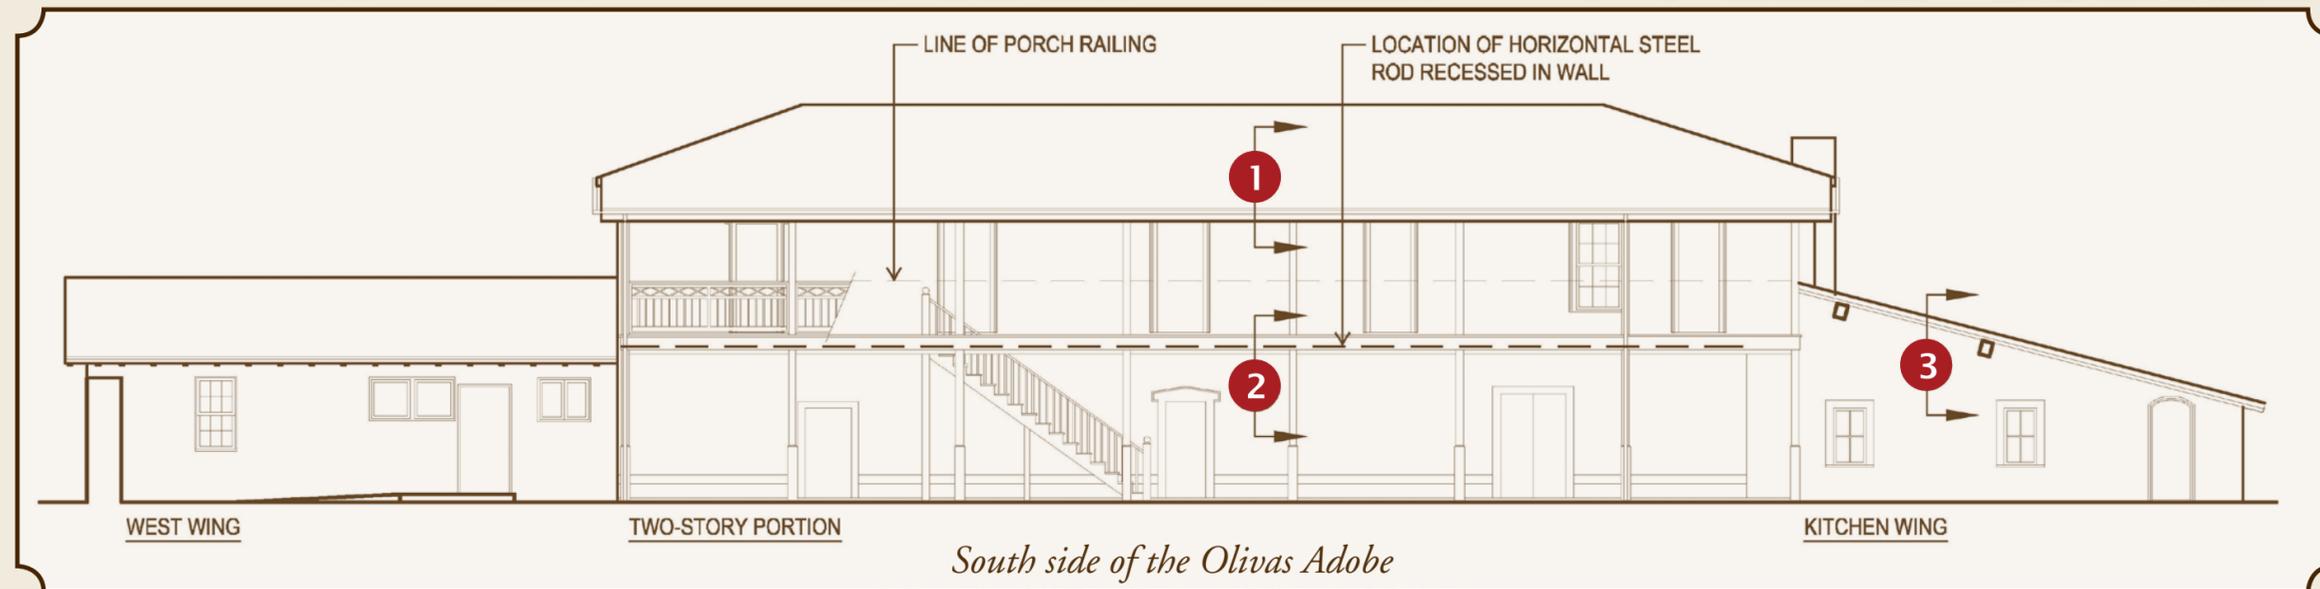
The Large and Small Adobes have been strengthened to improve safety and reduce potential damage in the event of an earthquake. The main approach was to tie the adobe walls and wood-framed floors and roof together so that they move in similar ways in response to any ground motion.

- 1 Attaching the roof to the walls:** Two-foot long vertical steel rods were driven into the top of the adobe walls and bolted to the rafters.
- 2 Attaching the walls to the floor:** Brackets attached to the second floor framing were anchored to a horizontal steel rod recessed into the plaster on the outside of the wall, just under the second floor porch. The floors were also bolted together through the interior walls between rooms.
- 3 Strengthening roof and walls:** The roof was strengthened by adding plywood sheathing over the framing. The walls were also strengthened along the top, either with steel straps attached to the roof framing and adobe wall, or with a reinforced concrete cap, called a “bond beam” installed on the adobe just under the roof framing.
