**CITY OF SAN BUENAVENTURA**

**RIP-RAP STANDARD DETAIL**

**406**

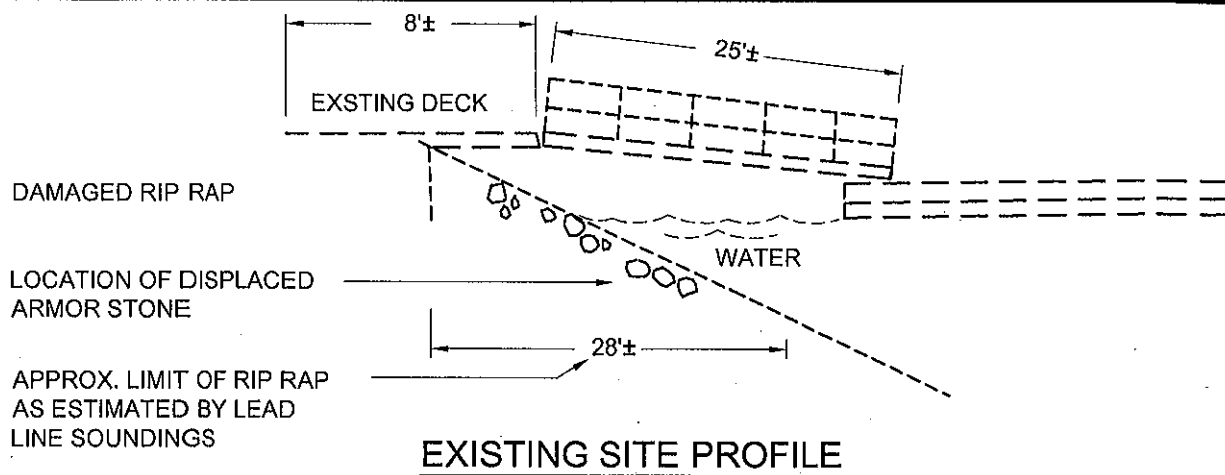
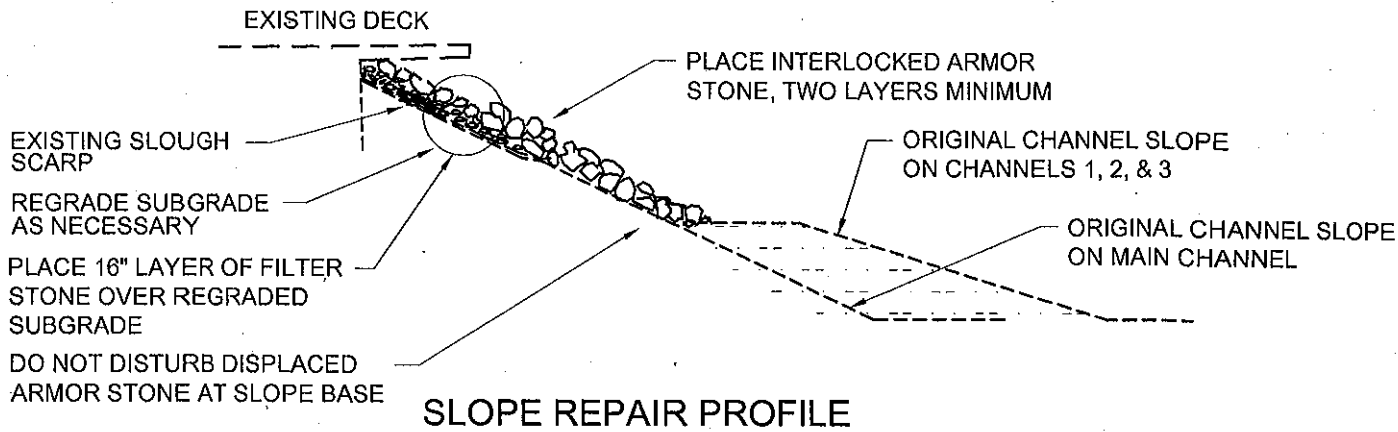
NOTE: TIDE MARK IS THE LINE BETWEEN THE DARK, WATER STAINED ROCK AND THE LIGHTER COLORED, UNSTAINED ROCK.

REMOVE EXISTING ARMOR STONE AS NECESSARY IN THE AREA TO BE REPAIRED. REGRADE AS NECESSARY AND FILL TO A UNIFORM SLOPE WITH IMPORTED FILTER STONE. FILTER STONE SHALL BE A MINIMUM UNIFORM DEPTH OF 14" TO 18". RE- PLACE EXISTING ARMOR STONE AND IMPORTED ARMOR STONE OVER FILTER STONE TO A MINIMUM DEPTH OF TWO LAYERS AND INTERLOCKED. ARMOR STONE INTERSTICES SHALL BE FILED WITH COBBLE STONE.

- ARMOR STONE- 150 TO 200 POUND STONE.
- COBBLE STONE- 6 TO 12" DIAMETER STONE.
- FILTER STONE- 4" MINUS.
